System Rejuvenation on Tight Site on Whaley Lake, Dutchess County, New York

Problem: Failing metal septic tank in need of a rejuvenated leach field on a beautiful recreation lake in Dutchess County NY.

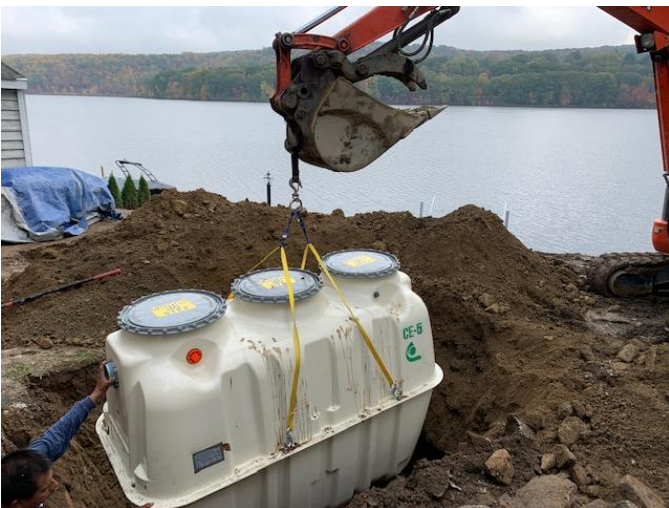
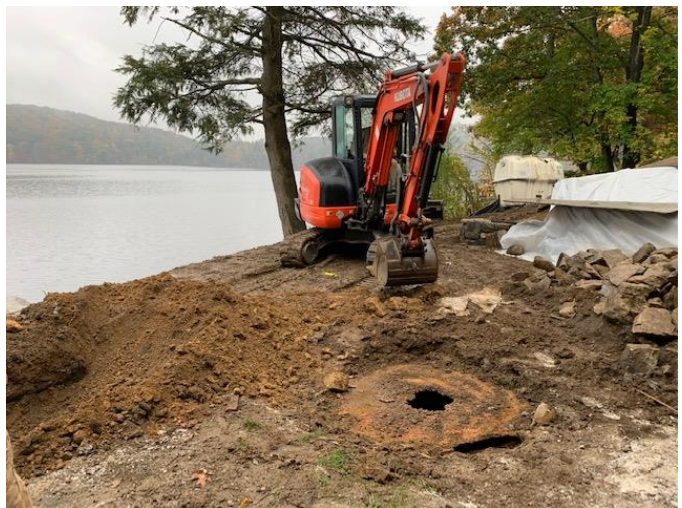
- Sloping site with a small footprint
- System within 30' of lake edge
- Replacing failed old metal tank
- Dispersal into existing leaching pits

Solution: Use a lightweight and small footprint FujiClean advanced treatment unit to discharge highly treated & oxygenated effluent into existing leach pit for rejuvenation.

- FujiClean Model CE5 (Hydraulic design capacity; 500-gpd)
- Proven treatment results of BOD <15 mg/L and TSS <15 mg/L
- One tank treatment with tiny footprint and low profile (85"L x 44"W x 62"H)
- Lightweight (<400 lbs.) easy to maneuver into location
